SILVER STAR FREIGHT SUBAREA STUDY PHASE II FINAL REPORT

June 2021

EXECUTIVE SUMMARY

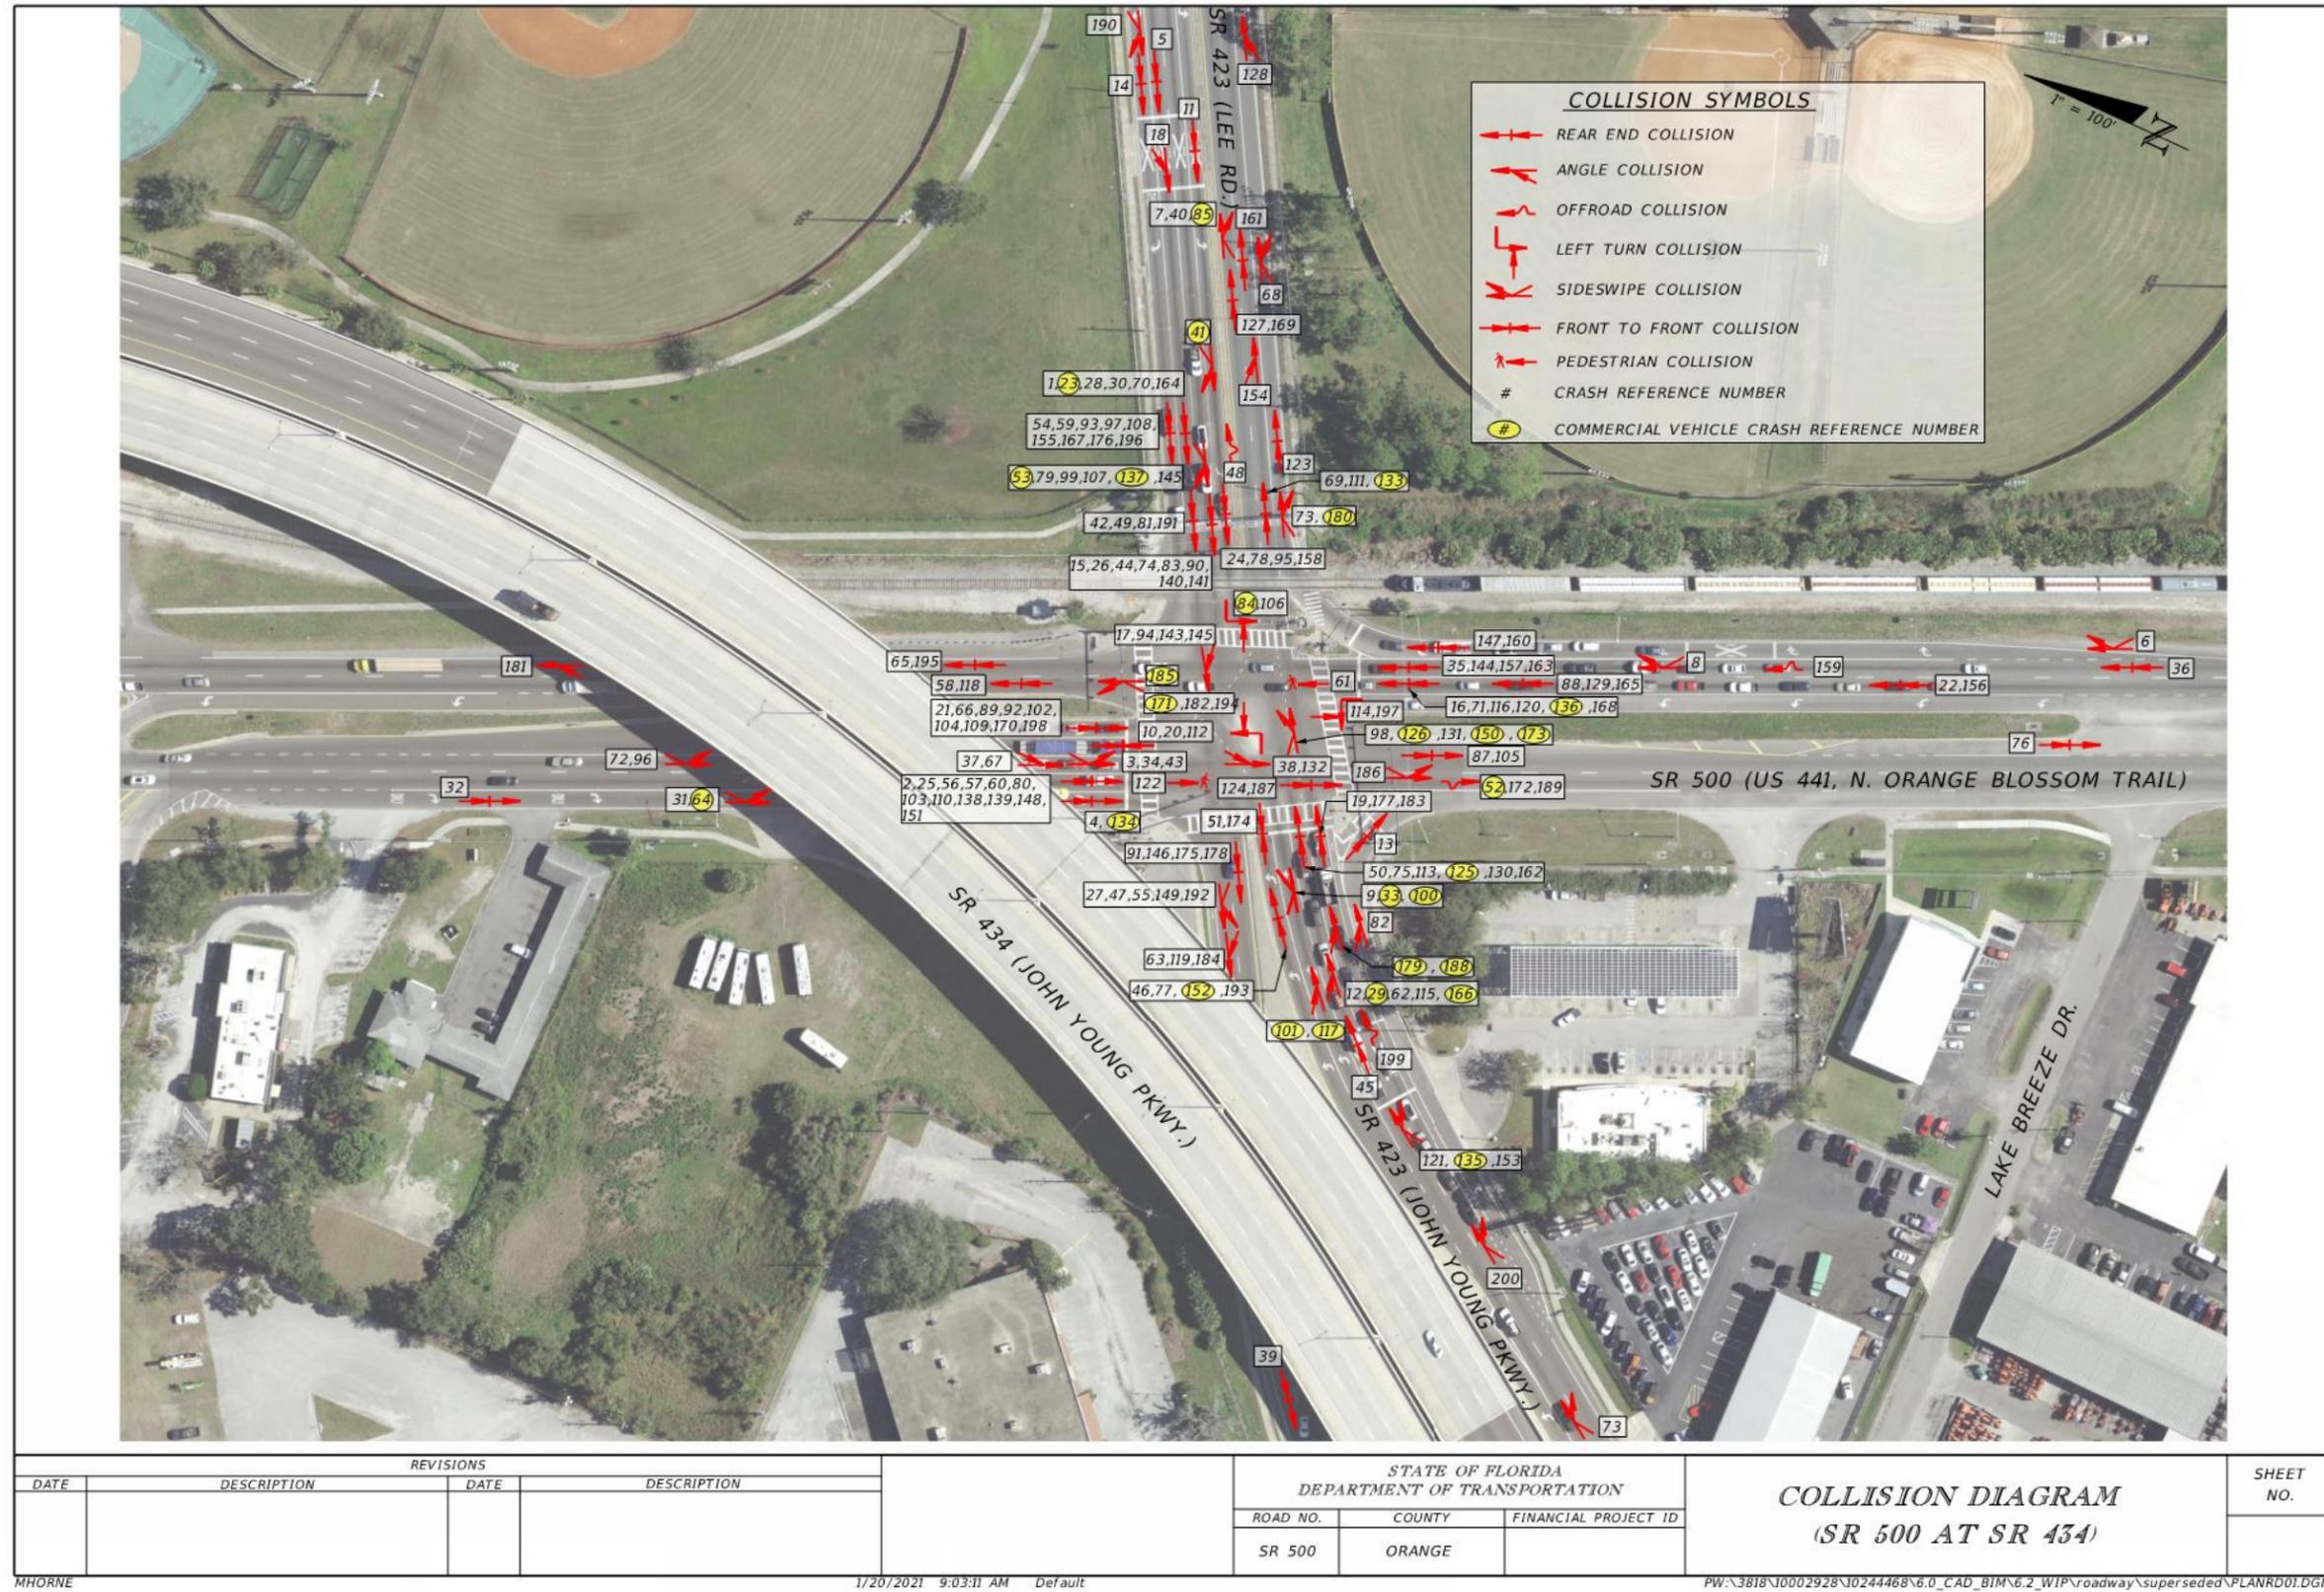
REVISIONS				STATE OF FLORIDA DEPARTMENT OF TRANSPORTATION			COLLISION DIAGRAM (SR 500 AT SR 434)	SHEET NO.
DATE	DESCRIPTION	DATE	DESCRIPTION	ROAD NO.	COUNTY	FINANCIAL PROJECT ID		
				SR 500	ORANGE

In total, there were 200 crashes reported in the past five years (2013-2017), out of which 30 (15 percent) crashes were commercial vehicle crashes. There have been one pedestrian crash and four bicyclist crashes reported. Most of the intersection crashes 106 (53 percent) were rear end crashes. The angle and sideswipe crashes were reported as 31 (16 percent) and 41 (21 percent), respectively. However, a higher percentage of the commercial vehicle crashes were found as sideswipe crashes (50 percent). The night-time crashes were reported as 18 percent for the five-year period.

Based on the intersection crash analysis the following intersection improvements are recommended to mitigate the identified safety issues.

1. Consider providing signal heads with backplates with retroreflective yellow border to reduce the high percentage of rear-end collisions at the intersection.
2. Evaluate and update the signal yellow and red times to accommodate the high percentage of heavy commercial vehicles.
3. Evaluate and enhance the intersection lighting particularly on the approaches and under the John Young Parkway overpass to mitigate the high number of crashes occurring in dark conditions.

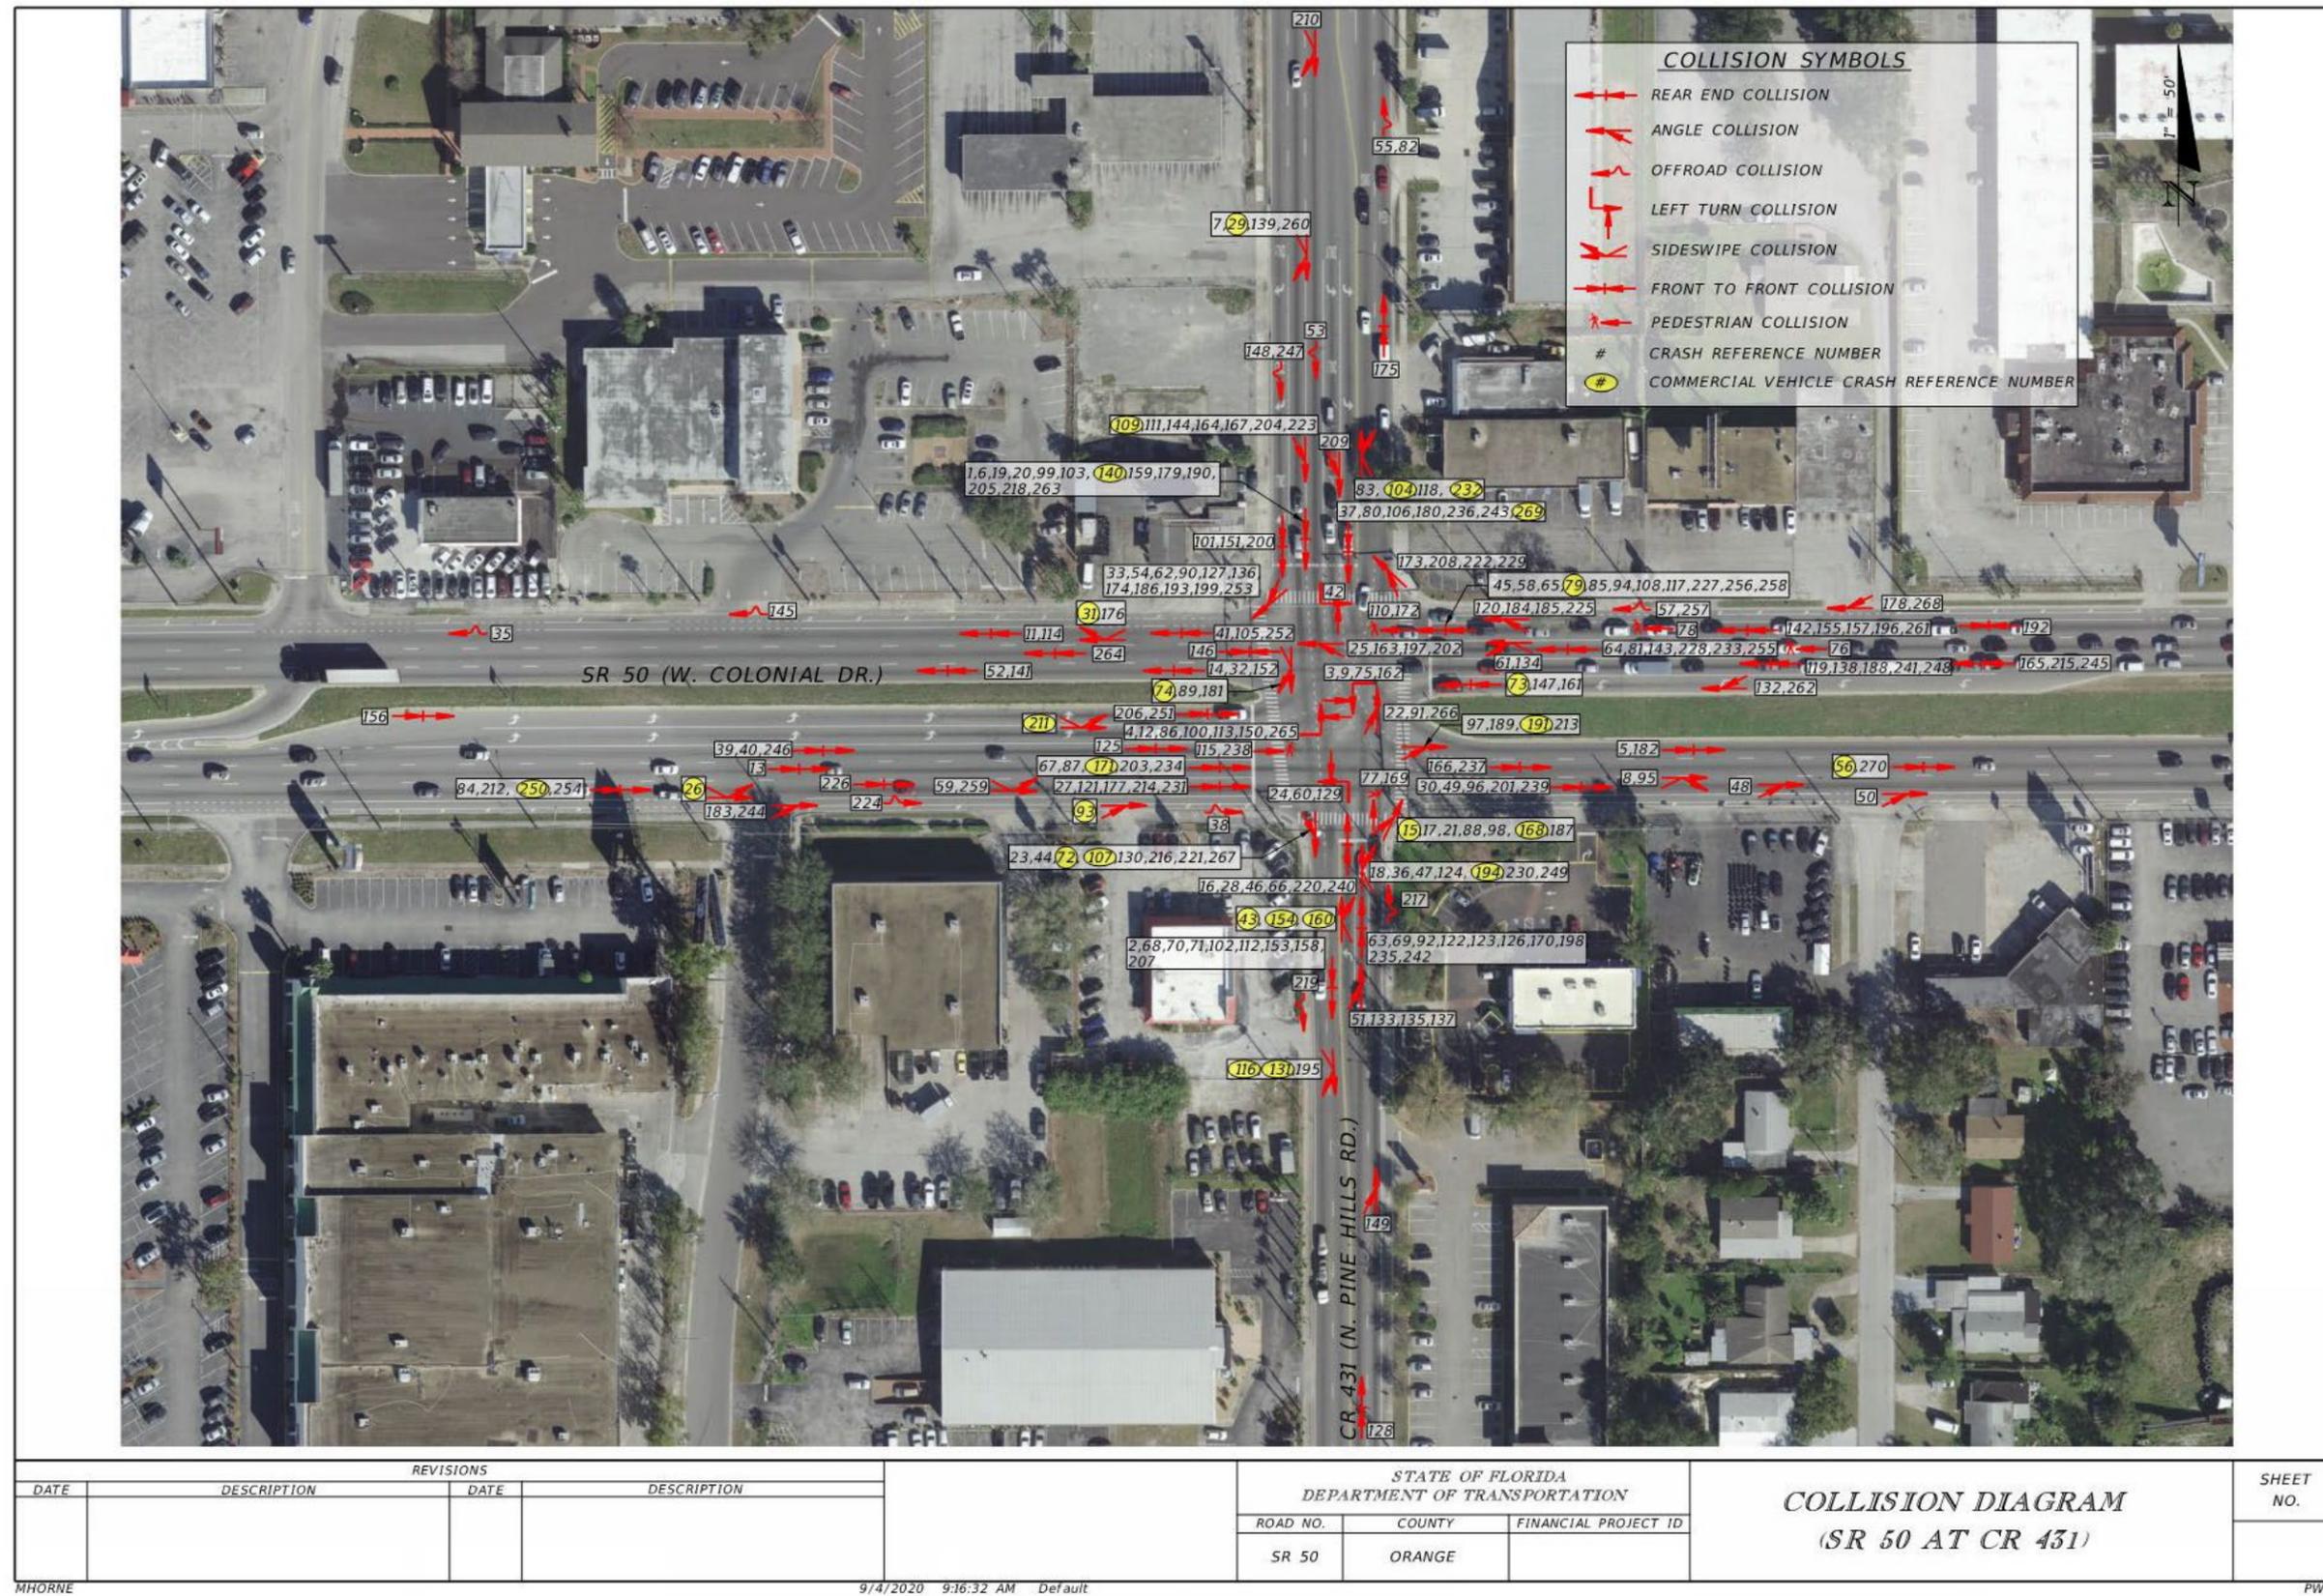
Figure 7. Pine Hills Road and Colonial Drive Intersection Crash Diagram

In total, there were 270 crashes reported in the past five years (2013-2017), out of which 27 (10 percent) were commercial vehicle crashes. There have been nine pedestrian crashes and six bicyclist crashes reported. One pedestrian crash and four bicycle crashes involved right turning vehicles. The highest percentage of intersection crashes 130 (48 percent) were rear end crashes. The angle and sideswipe crashes were reported as 68 (25 percent) and 30 (11 percent), respectively. However, a higher percentage of the commercial vehicle crashes were found as sideswipe crashes (41 percent). The night-time crashes were reported as 33 percent for the five-year period.

Based on the intersection crash analysis the following intersection improvements are recommended to mitigate the identified safety issues.

1. Consider providing signal heads with backplates with retroreflective yellow border to reduce the high percentage of rear-end collisions at the intersection.
2. Evaluate and update the signal yellow and red times to accommodate the high percentage of heavy commercial vehicles.
3. Provide LPI signal timing at all the intersection approaches to improve the pedestrian and bicyclist safety conditions.
4. Consider prohibiting RTOR at the intersection or installing yield to pedestrians and bicycles signs at intersection approaches.

5. Evaluate and enhance the intersection lighting to mitigate the high number of crashes occurring in dark conditions.
6. Consider evaluating innovative intersection concepts such as Median U-turn (MUT) or Restricted Crossing U-turn (RCUT) to reduce the vehicular conflicts and the number of crashes.

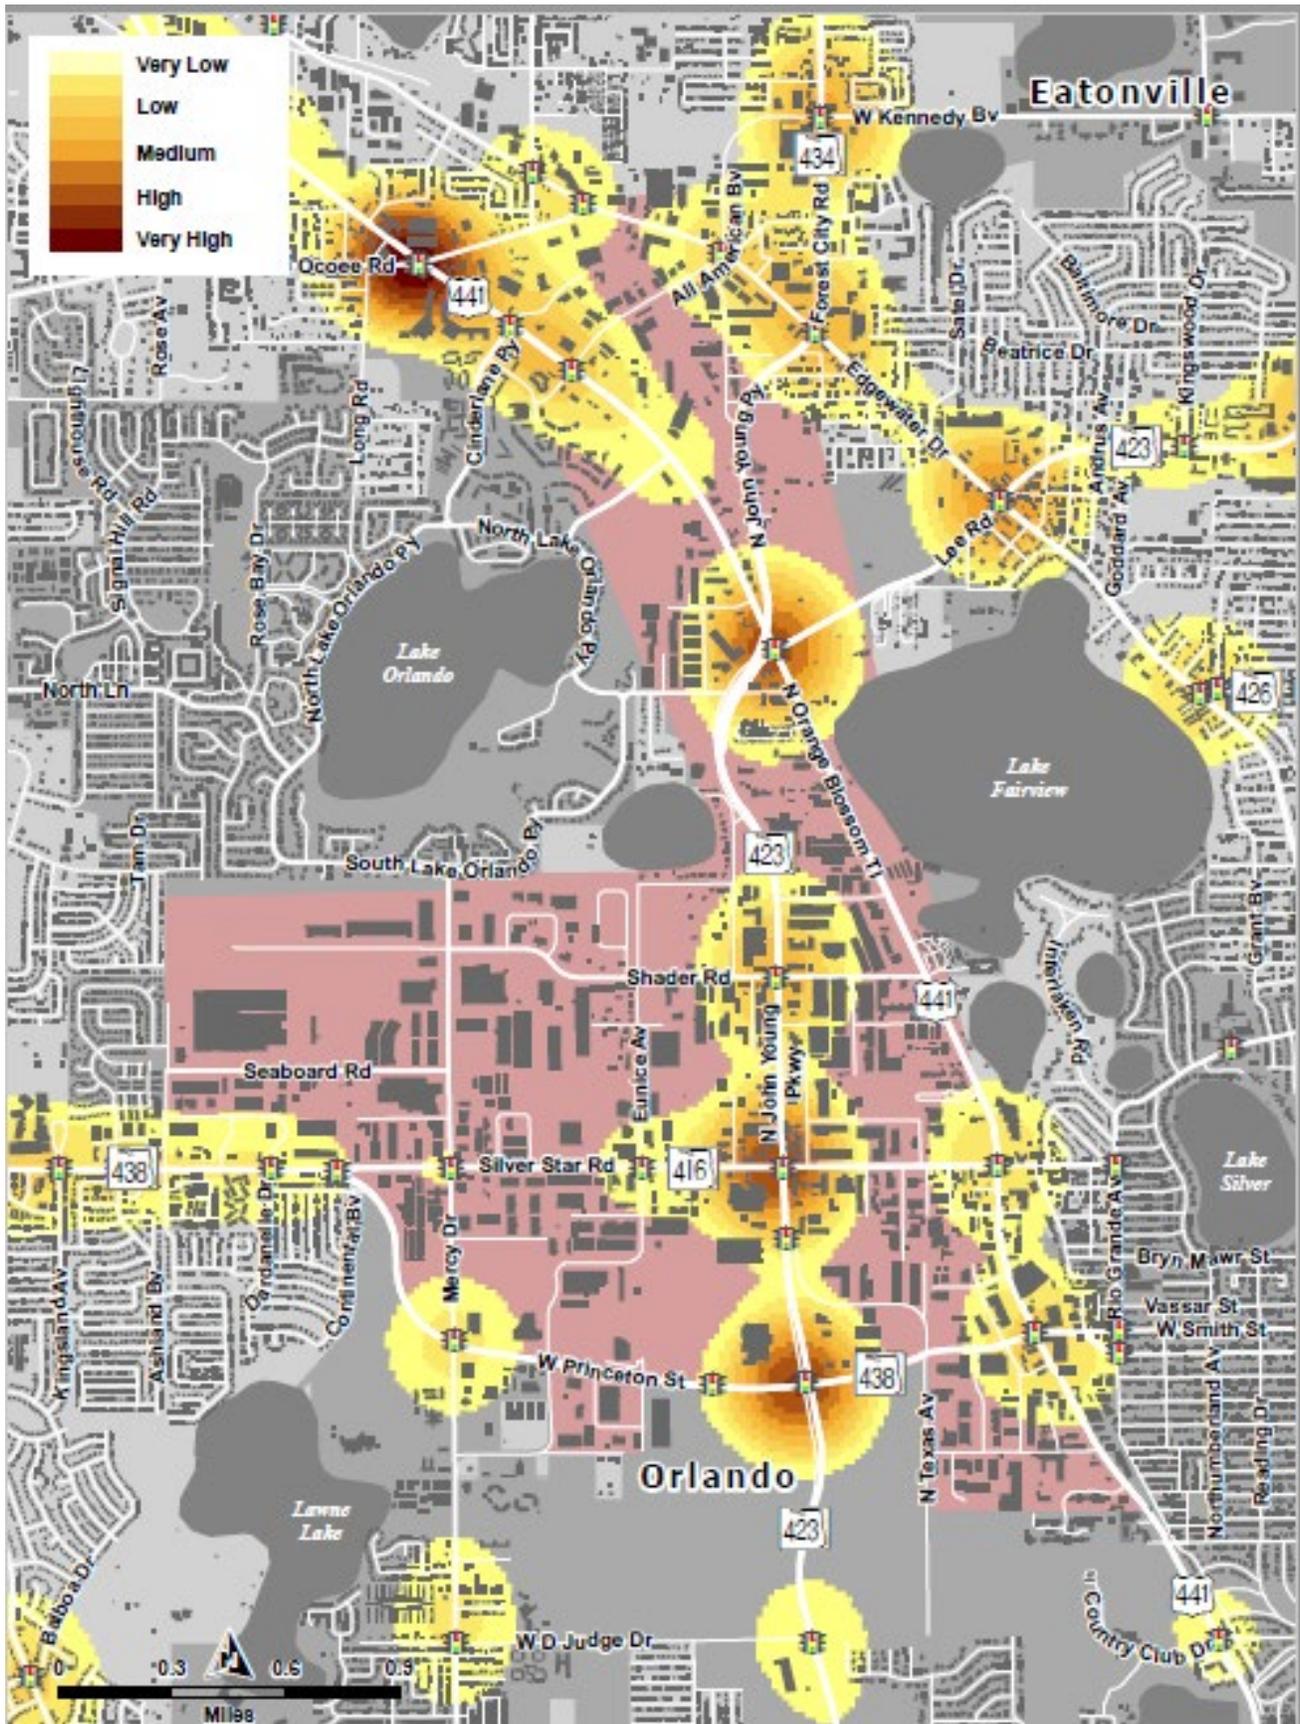
Figure 60. Crash Heat Map of Front-Rear Crash Types

Of the crashes involving trucks in the study area, 70 percent were not at intersections and 34 percent were front to rear, potentially indicating crashes due to queueing. **Figure 60** shows a crash heat map for front-rear collisions that occurred outside of intersections, which may be used as an indicator for the locations of end of queue crashes. The intersections of John Young Parkway and Princeton Street, Silver Star Road, and Orange Blossom Trail; as well as Orange Blossom Trail and Clarcona Ocoee Road all register a high number of potential end of queue crashes.

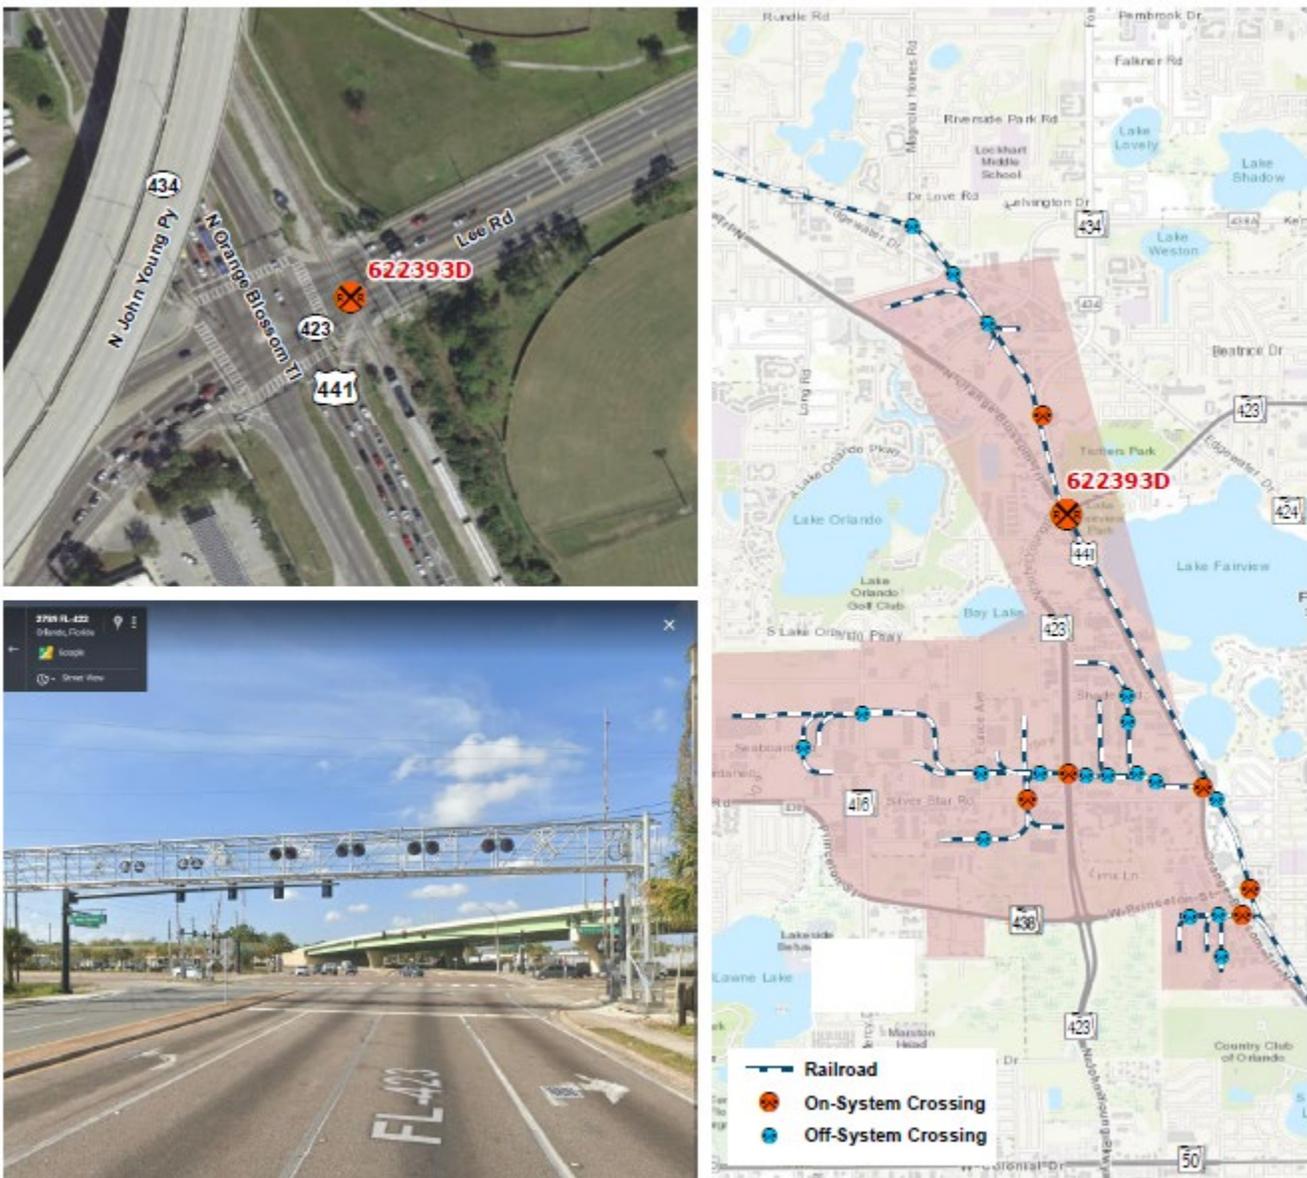
Figure 61. Lee Road Rail Crossing (622393D)

Of the railroad crossings assessed in the study area, the crossing on Lee Road, as shown in **Figure 61**, could be a candidate for rail crossing violation warning. Gates on the right turn lane from northbound Orange Blossom Trail to eastbound Lee Road have been damaged numerous times by vehicles. One proposed solution is the installation of advanced warning signs on northbound and southbound Orange Blossom Trail. Advanced warning signage could be supplemented by in-vehicle warnings for connected vehicles.

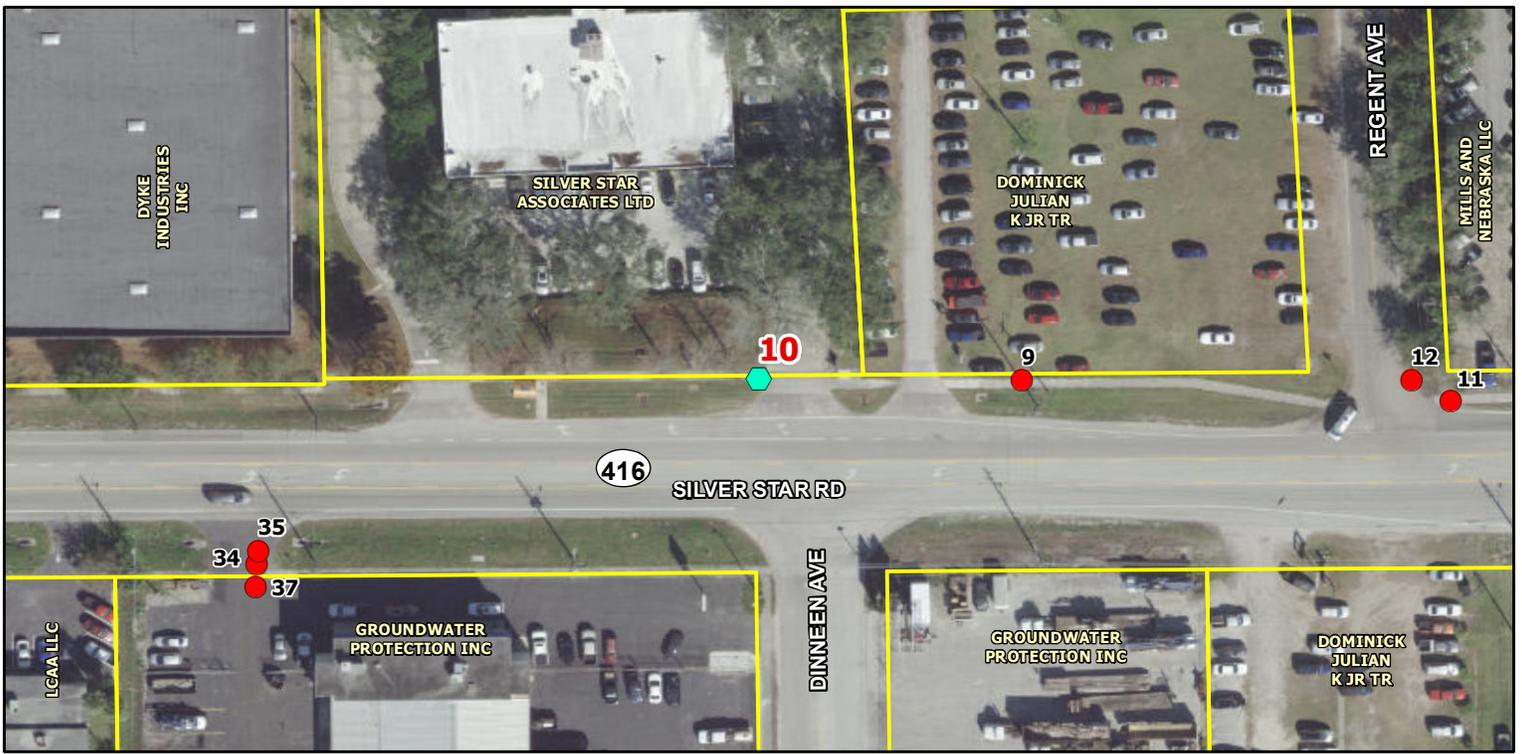
Feature ID: 10
Feature Type: Transit
Comment: Bus Stop with Shelter
Lat: 28.5783 **Long:** -81.41125
<http://maps.google.com/maps?q=28.5783,-81.41125>

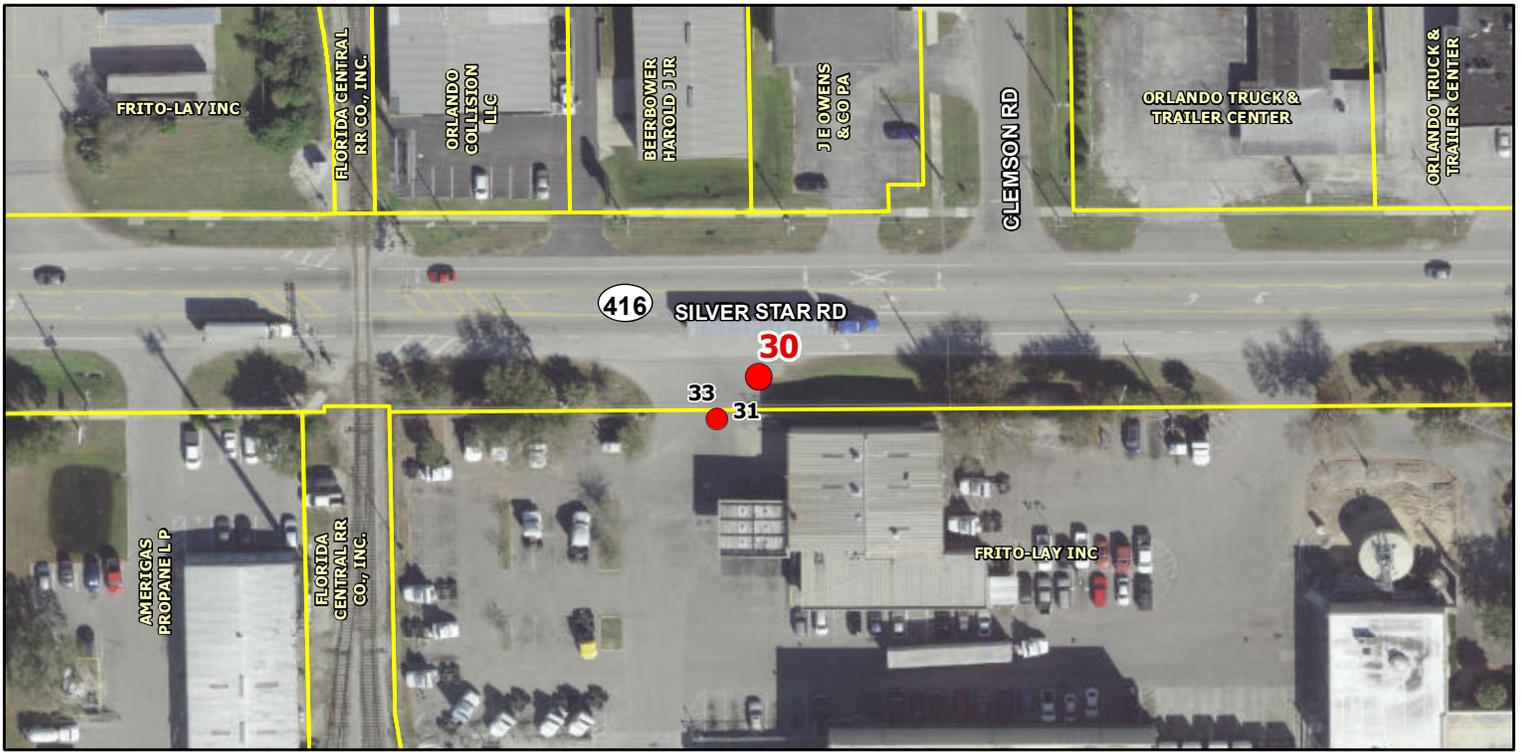
Feature ID: 30
Feature Type: ADA - Safety
Comment: no sidewalk
Lat: 28.57801 **Long:** -81.41881
<http://maps.google.com/maps?q=28.57801,-81.41881>

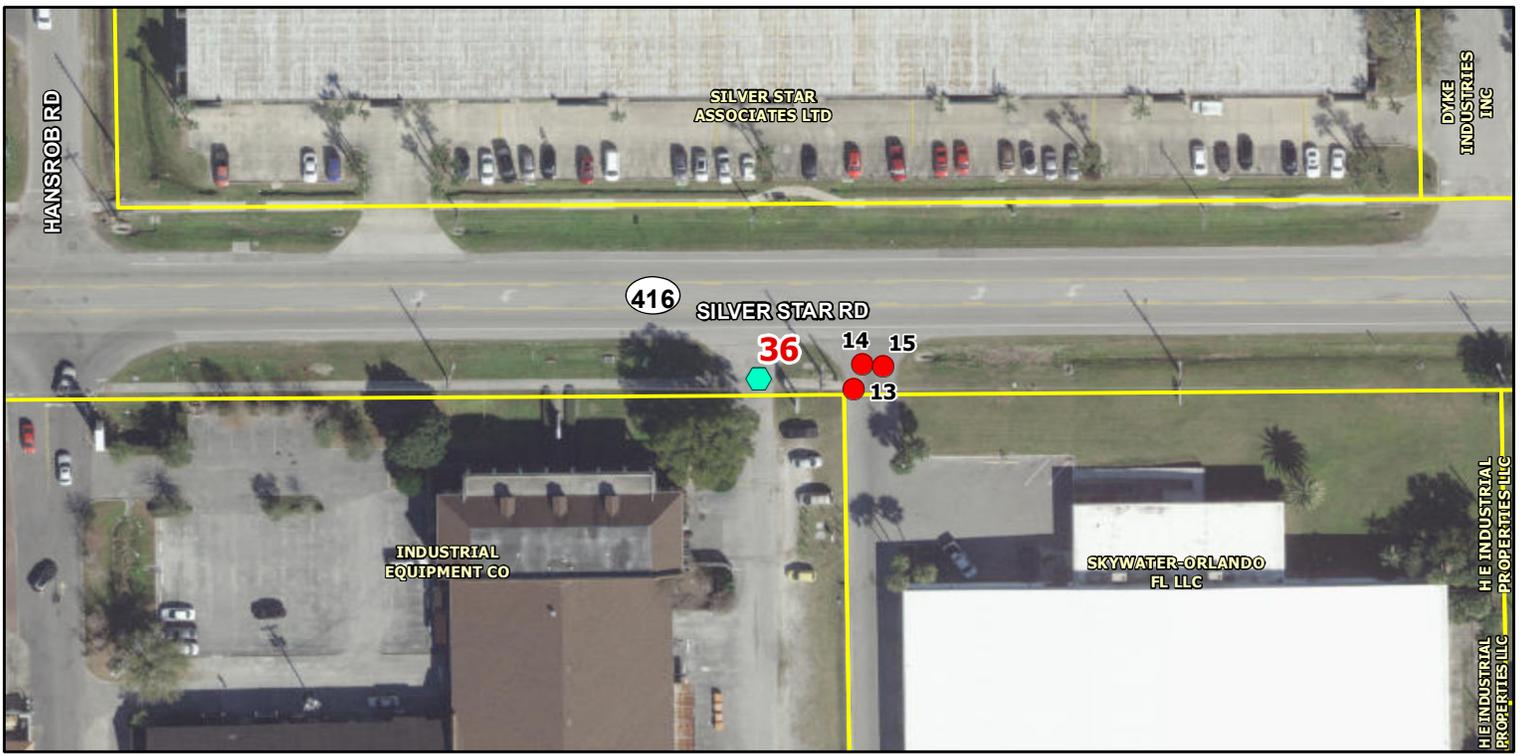
Feature ID: 36
Feature Type: Transit
Comment: bus stop, sidewalk ends
Lat: 28.57802 **Long:** -81.41428
<http://maps.google.com/maps?q=28.57802,-81.41428>

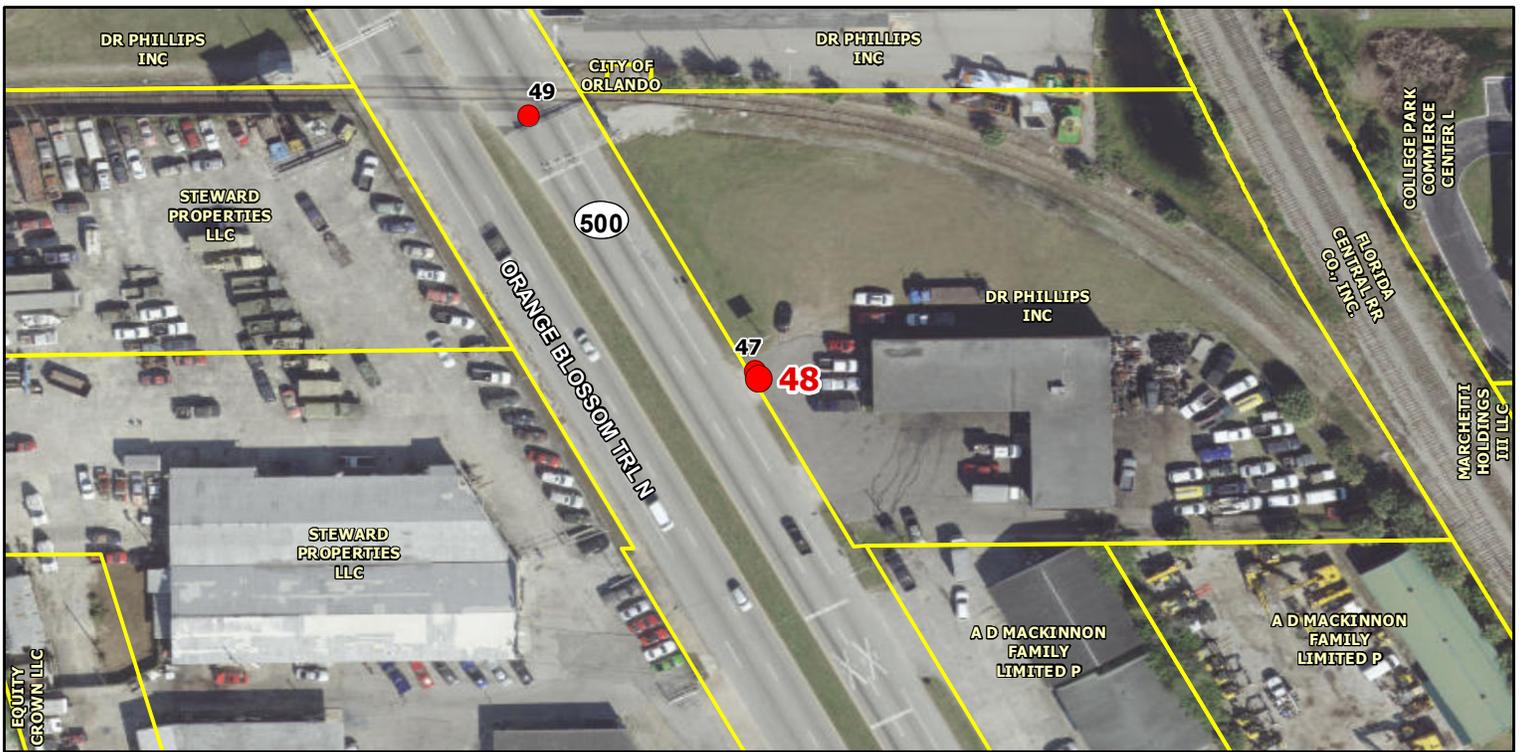
Feature ID: 48
Feature Type: ADA - Safety
Comment: no sidewalk
Lat: 28.56969 **Long:** -81.40395
<http://maps.google.com/maps?q=28.56969,-81.40395>

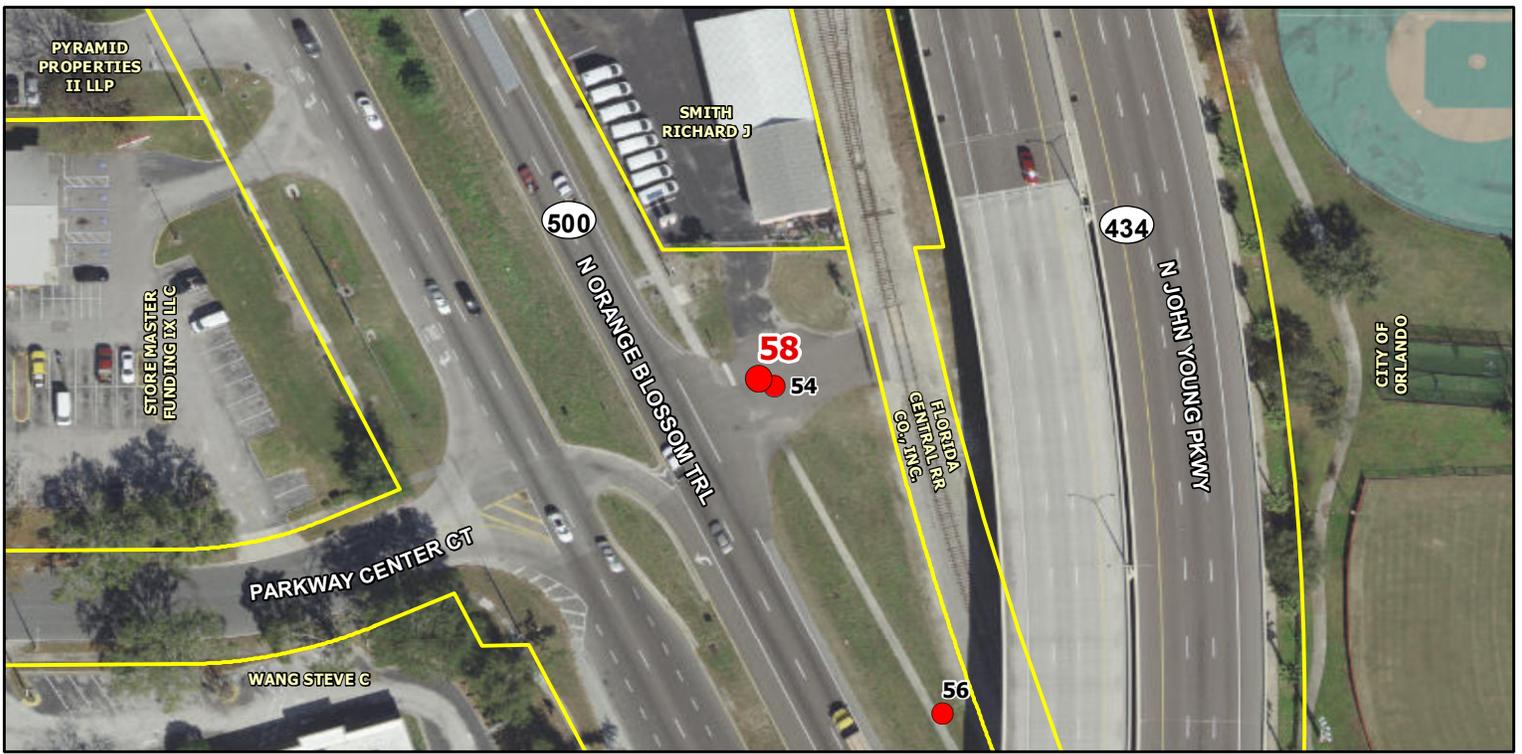
Feature ID: 58
Feature Type: ADA - Safety
Comment: sidewalk
Lat: 28.59994 **Long:** -81.41765
<http://maps.google.com/maps?q=28.59994,-81.41765>

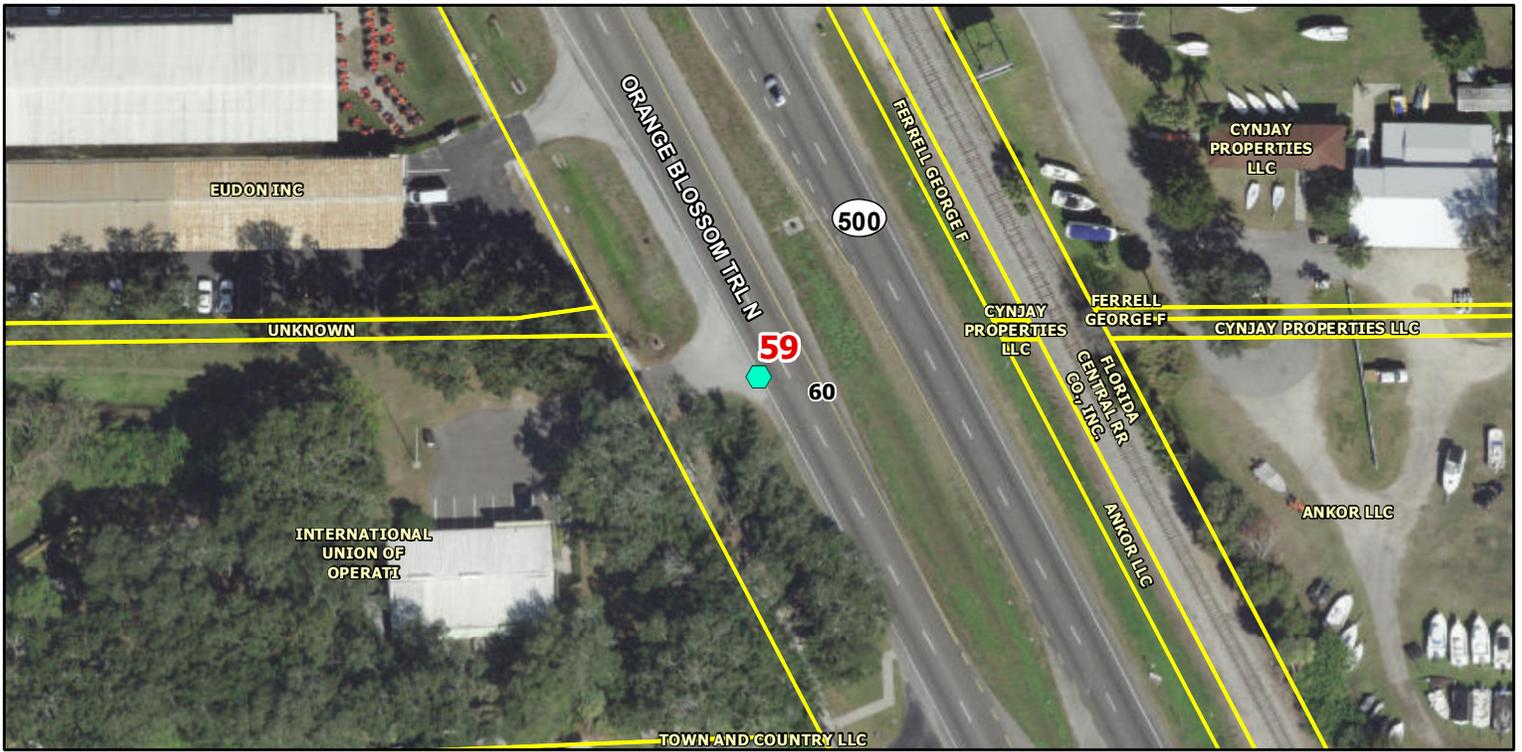
Feature ID: 59
Feature Type: Transit
Comment: people sitting at stop on grass
Lat: 28.59565 **Long:** -81.41581
<http://maps.google.com/maps?q=28.59565,-81.41581>

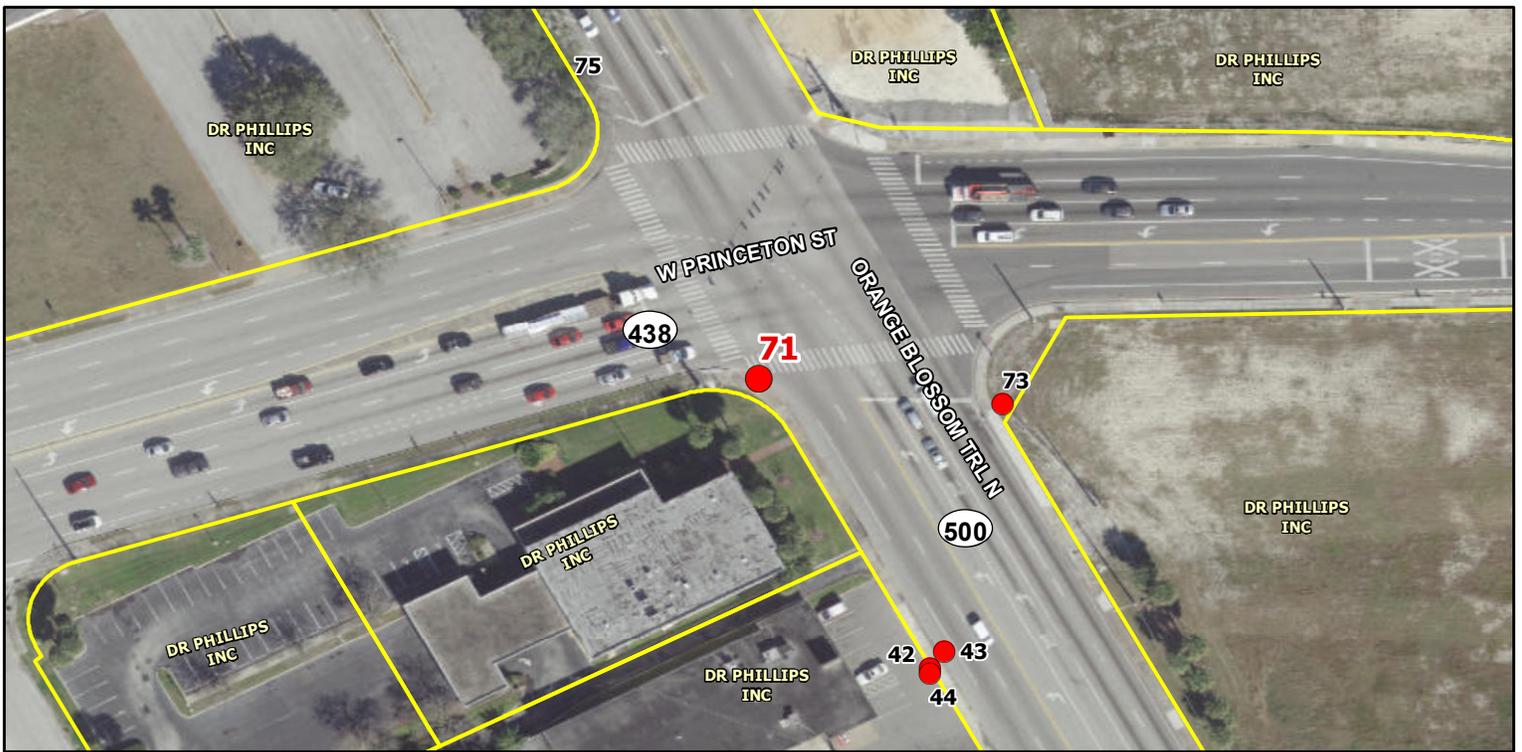
Feature ID: 71
Feature Type: ADA - Safety
Comment: crosswalk
Lat: 28.57161 **Long:** -81.40543
<http://maps.google.com/maps?q=28.57161,-81.40543>
